THE RESTORATION OF THE ERECHTHEION

AN ENTRY FOR EUROPA NOSTRA AWARDS 1987

BY A.PAPANIKOLAOU - C.ZAMBAS

THE RESTORATION OF THE ERECHTHEION (1979-1987)

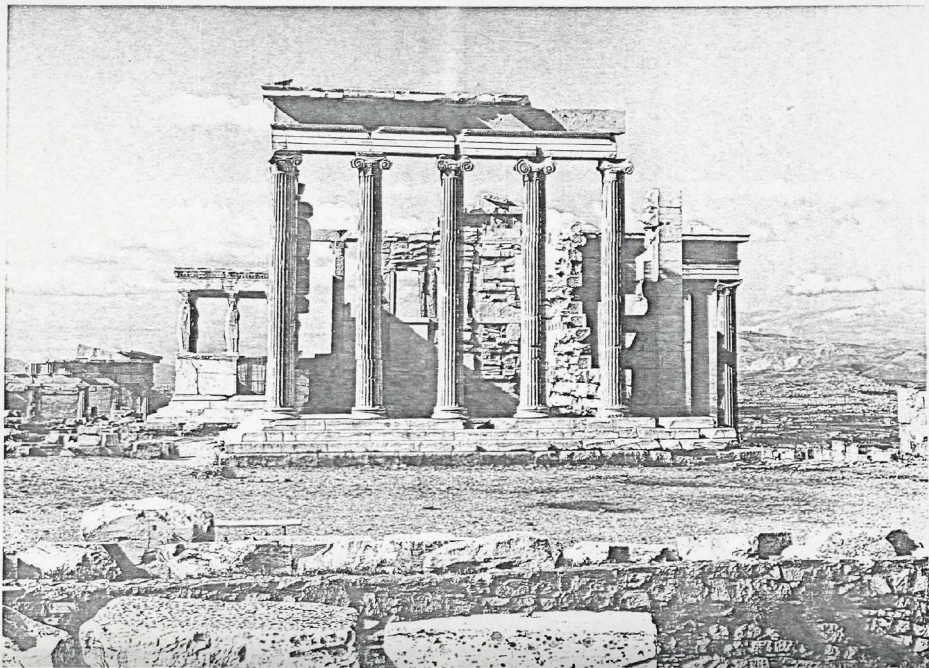
View of the Erechtheion from the east before (above) and after restoration

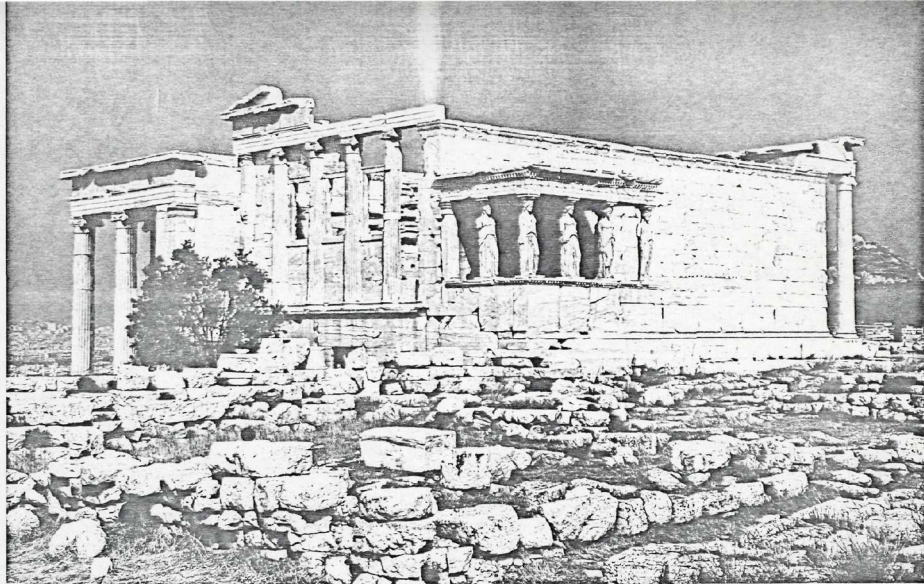
View of the Erechtheion from the southwest before (above) and after restoration
